The Barsem disaster

Barsem Village is located on a large alluvial fan and adjacent smaller fluvial terraces. Around 1500 people lived in this village located in the south-eastern corner of Tajikistan, next to the border with Afghanistan, about 20 km upstream of Khorogh, the main town in Badakhshan.

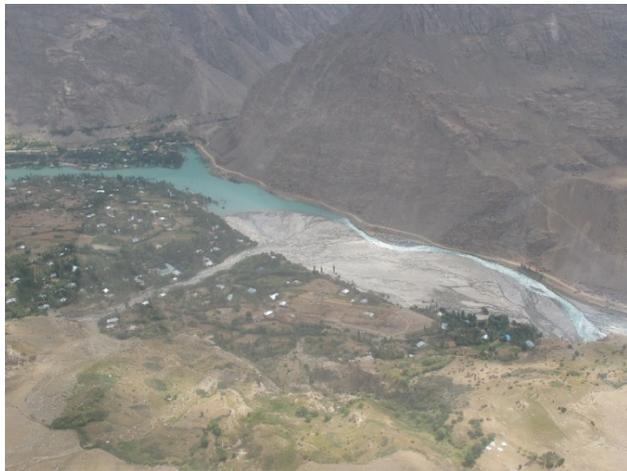
Photo by Sven Fuchs, 28 Aug. 2015

At least 14 major debris flows occurred in the Barsem Valley (24 km²) between 16th and 20th July 2015 during an exceptional period of hot weather combined with exceptional rainfall.

The flows transported large volumes of debris on the fan at Barsem. According to a rough estimate, the area covered is 300,000 m² and has an assumed average thickness of 6 m with volume of the order of 1.5 million m³. This is comparable to the Dasht glacial lake outburst flood of August 2002 (Dasht, in Roshtkhala District, Tajikistan). The debris flows formed a natural dam in the Gunt Valley. The maximum height of the deposits could be of the order of 20 m. A lake formed behind the dam, having a length of about 2 km and a volume of approx. 4.5 million m³.

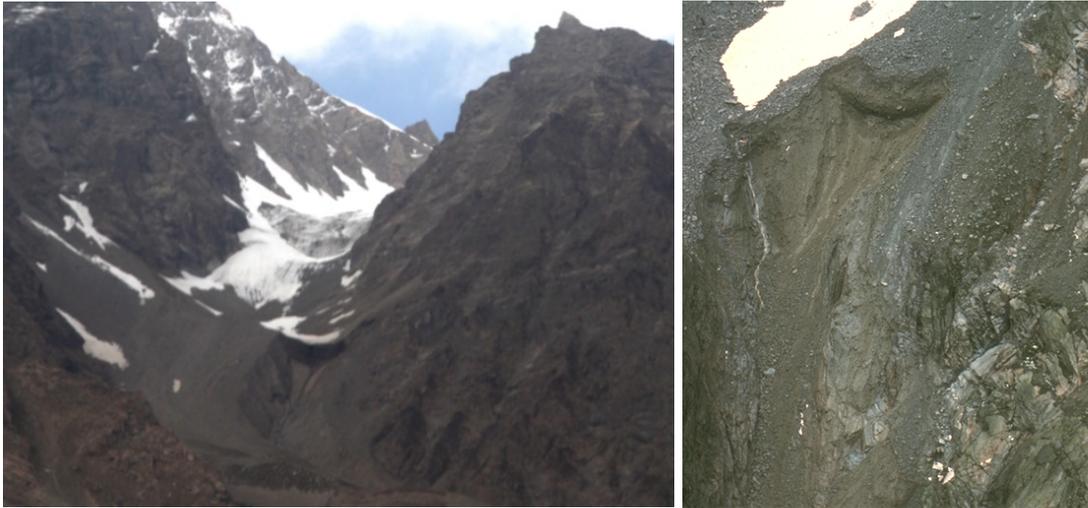
Barsem starting zone (left; photo by Sven Fuchs, 28 August 2015). The steep (almost vertical) scarp is an indication that the debris is still frozen. A similar condition was observed in August 1987 in the Swiss Alps at Saas Glacier, Oberwald, Valais (right; photo by Wilfried Haerberli, ETH, 27 August 1987).

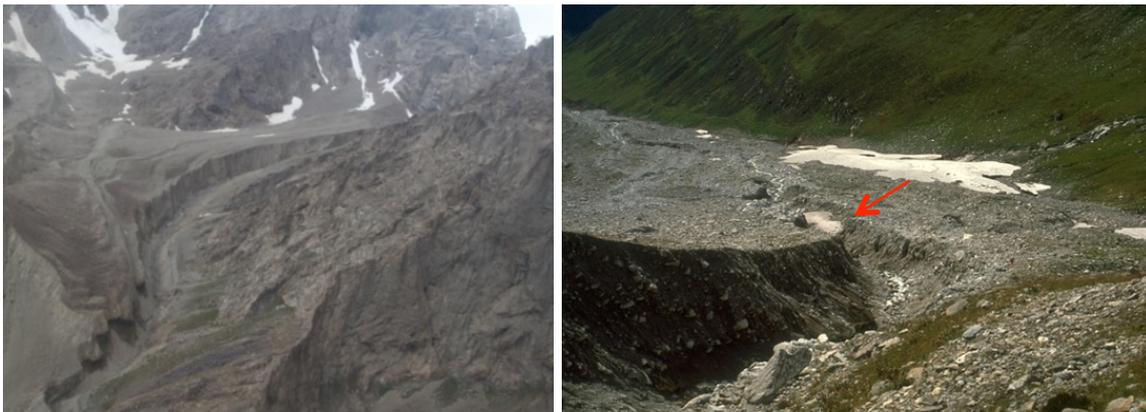
The erosion within a thick scree deposit is of huge dimensions: an average cross-section of at least 500 m² can be assumed over a reach of at least 1000 m length. This is definitely bigger than what has been observed during the Saastal event in 1987.

Barsem erosion in debris (left; photo Sven Fuchs, 28. Aug. 2015) and similar condition at Saas Glacier, Oberwald, Valais (right, photo Markus Zimmermann, 16 July 1989). The arrow points to a person standing beside the eroded channel (event 1987)

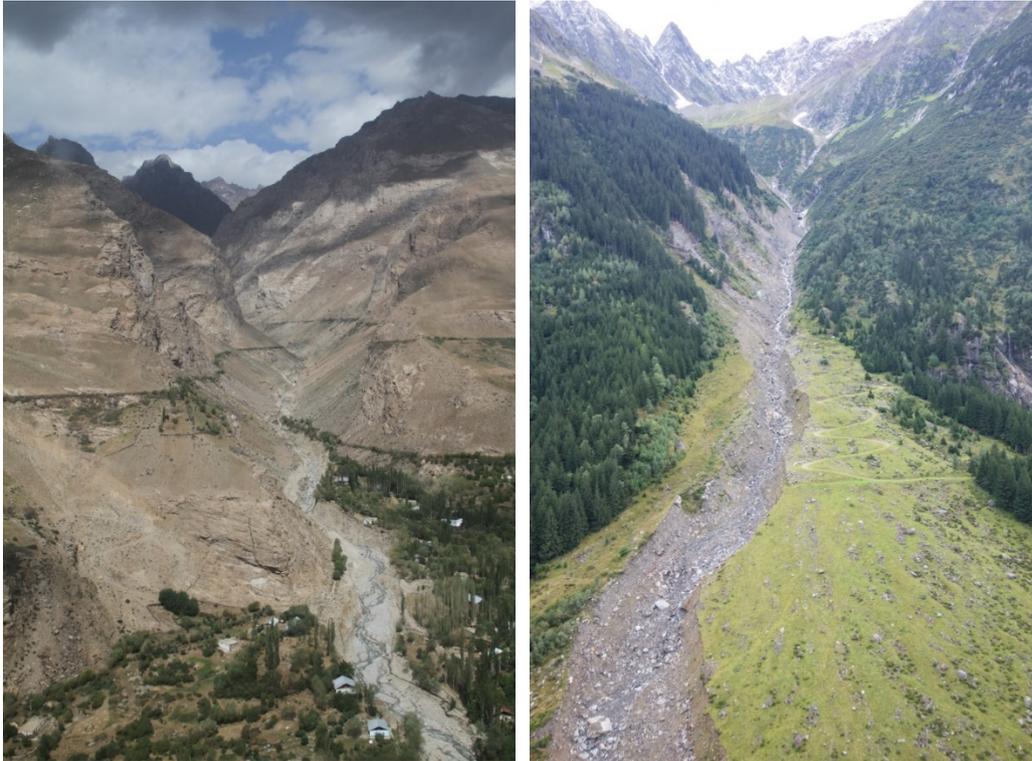
Large parts of these eroded sediments were deposited on a terrace about 1000 m below the source. The remaining flows further eroded the channel of Barsem creek over the whole length. Similar phenomena could be observed in a site in the Bernese Oberland (Rotloui) where a debris flow considerably eroded the bed, even in the fan area (500,000 m³).

Channel erosion at Barsem creek (left, photo Markus Zimmermann, 28 August 2015) and Rotlauri, Switzerland (right, photo Markus Zimmermann, 3 Sept. 2013).

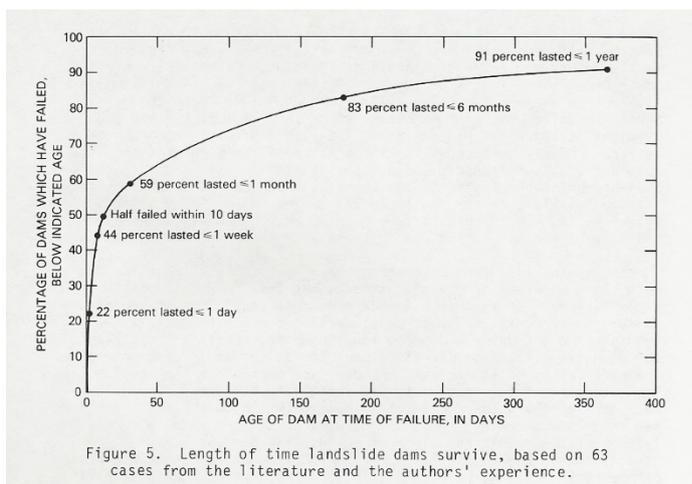
Length of time landslide dams survive, based on 63 cases from the literature and the author's experience (Schuster 1986, p. 10).

The deposits created a natural dam in Gunt Valley and dammed Gunt River. It can be assumed that the natural dam is rather stable because: a) the debris flows transported huge boulders armouring the "spill way"; b) the slope of the active channel is rather gentle (less than about 8 %); c) the water at the outflow is completely clear, therefore, already in August there was neither superficial erosion occurring, nor through seepage. According to an empirical study (Schuster 1986¹), about 22 % of such dams collapse within 1 day and 50 % within the first 10 days. If the dam survives 6 months its failure probability is 17 %. Nevertheless, a collapse of the Barsem dam cannot be completely excluded; particularly in the coming melt season further erosion is possible.
